Bord Iascaigh Mhara
Irish Sea Fisheries

Assessment of Acoustic Deterrent Devices in Irish Gill Net and Tangle Net Fisheries

Marine Technical Report : Project 05MT07

November 2005

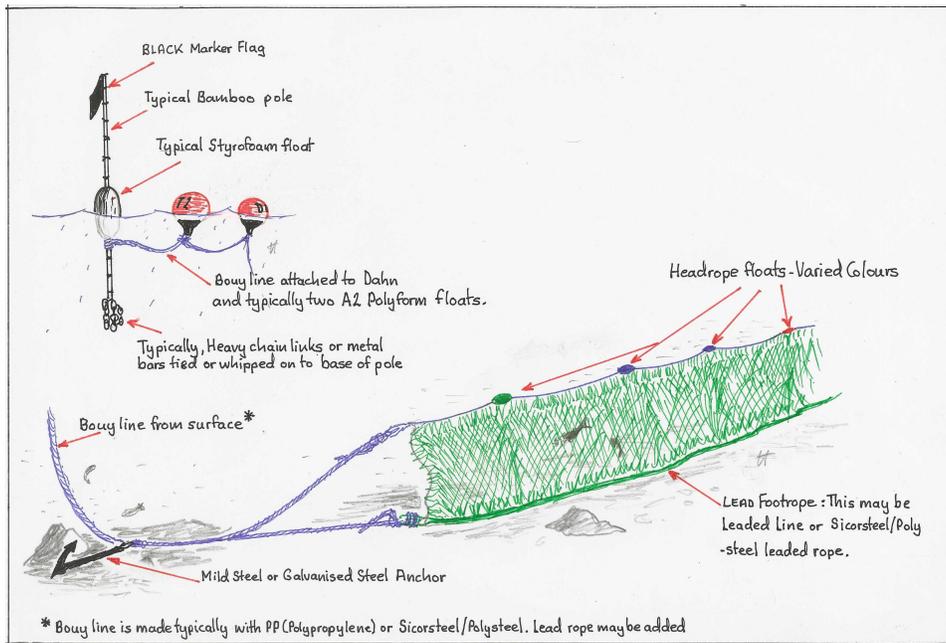
Figure 2. Outline of typical bottom set gill nets in Irish fisheries

A gill net can be defined as a length of multi- or monofilament mesh suspended between a buoyant headrope and a weighted footrope. Bottom set gill nets which are simply termed gill nets in this study are designed to catch fish whose body size is almost uniform since the mesh size must be matched to the fish's girth; the mesh size used depends on the species and size range being targeted. The headrope floats above the footrope that is set hard to the bottom and the meshes are spread between the two (Figure 2).

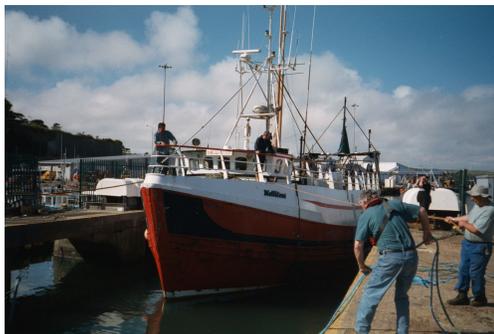
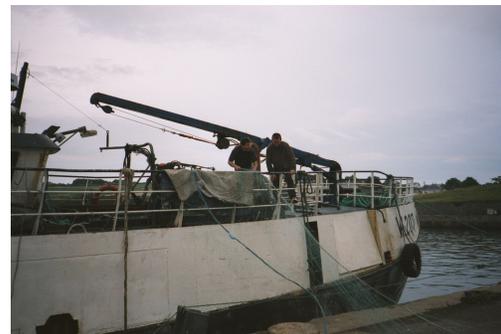
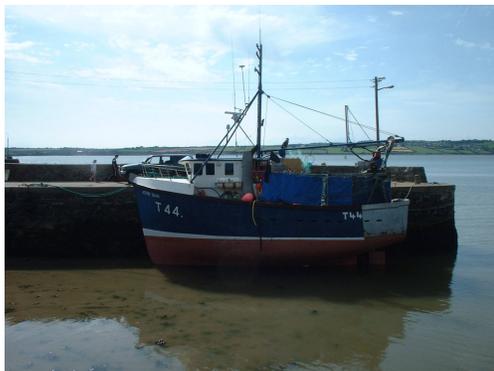
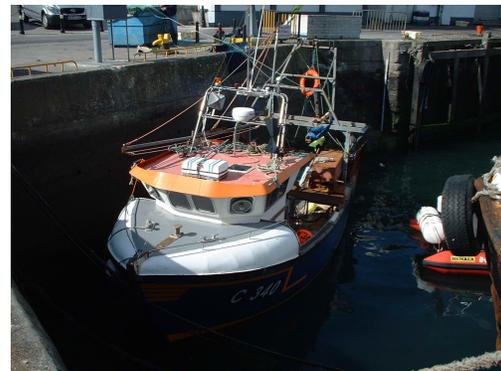
MFV Mellifont

MFV Berachah

MFV Western Dawn

MFV Stephanie Girl

Figure 3. The 4 vessels involved in the study

Four vessels (Figure 3) based in the south east of Ireland were chartered for the trials and are described in Table 2. Three of the vessels are full time gill netters based at the Co. Wexford port of Duncannon. The remaining vessel, the Stephanie Girl is based at the Co. Waterford port of Dunmore East and uses tangle nets for monkfish and turbot between May and September. All of the vessels had net haulers, and all with the exception of the Stephanie Girl had net flaking machines.

The Mellifont is wooden hulled with a forward wheelhouse, partially shelter decked and employs gill nets and tangle nets targeting cod, hake, monkfish and turbot throughout the year. The vessel successfully carried out trolling for albacore for the first time from July to October 2005. The Berachah is also wooden hulled but with a wheelhouse to the aft. The vessel also targets cod, hake, monkfish and turbot with gill nets throughout the year. The Western Dawn targets hake and cod using gill nets but had recently commenced trolling for albacore tuna in August and September 2005. The Stephanie Girl is a Holton 32 type trawler/potter, which carries out dredging for clams, tangle netting for turbot and trawling for herring on a seasonal basis. Both the Western Dawn and the Stephanie Girl are constructed from glass reinforced plastic with forward wheelhouses. Although the Stephanie Girl is less than 12m in length and will therefore not be affected by the acoustic deterrent regulation, the vessel uses fishing gear and methods similar to vessels over 12m in length and was therefore suitable for the tangle net work carried out in this study.

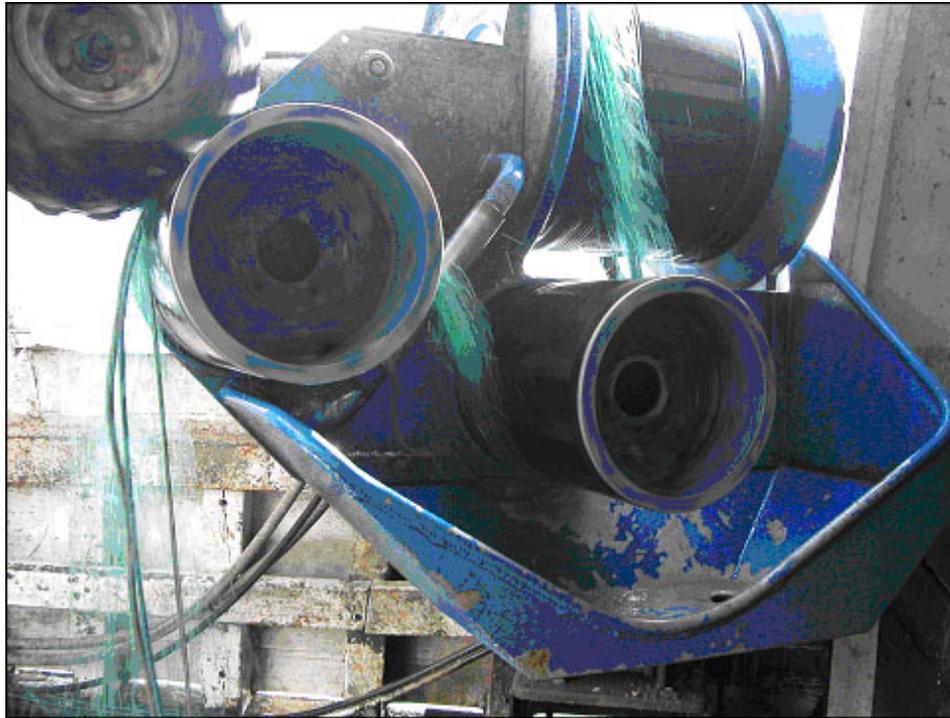
Figure 4. Spencer-Carter NH12 net hauler hauling gill nets on MFV Berachah.

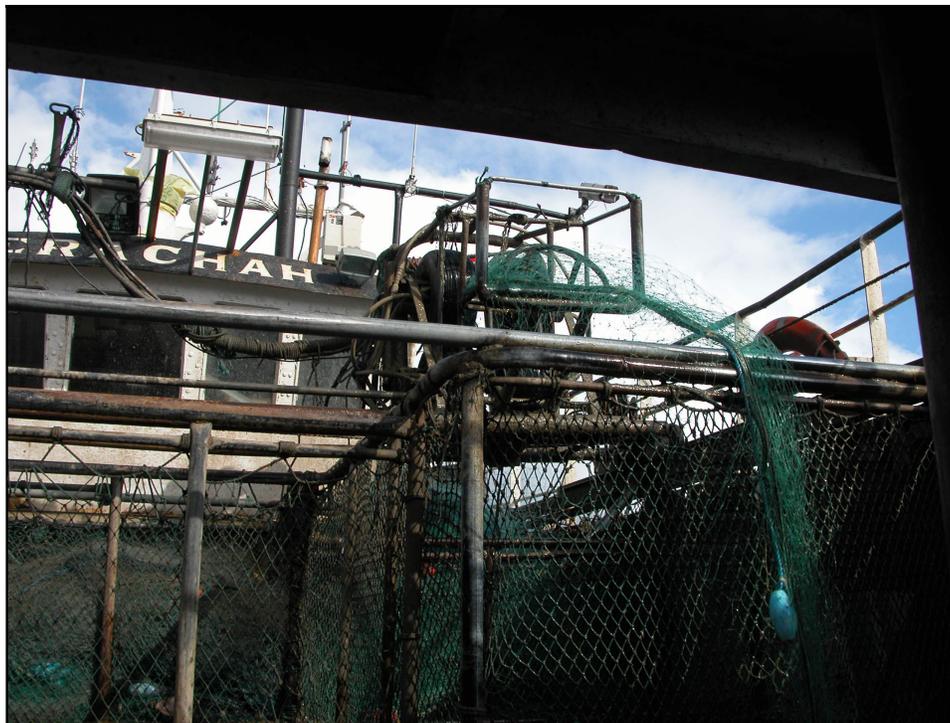
Figure 5. Net flaking machine and net pounds on MFV Berachah.

The flaking machine hauled the gear from the deck, separated the headrope and footrope and transported the nets into the net pound. When a pinger was fouled, the gear tended to jam in the flaking machine and meshes were torn if the gear was forced through. In response the crew either hauled the net back in order to clear the gear before it was passed back through the flaking machine, or the crewman in control of the flaking machine climbed to the top of the pound to release the fouled pinger. It should be noted that this problem was not restricted to pingers and also occurred on occasion with net floats. Climbing to the top of net pounds (>2m high) was dangerous especially in heavy seas and the presence of pingers on the gear increased the frequency with which it was necessary to do this.

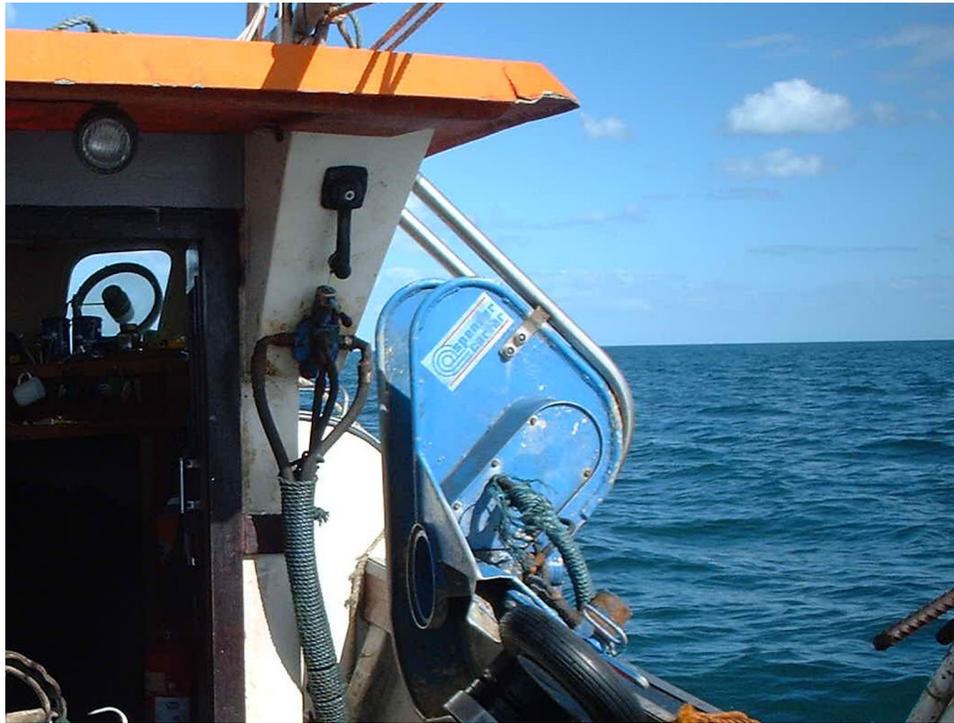
Figure 6. Spencer-Carter NH03 net hauler onboard MFV Stephanie Girl

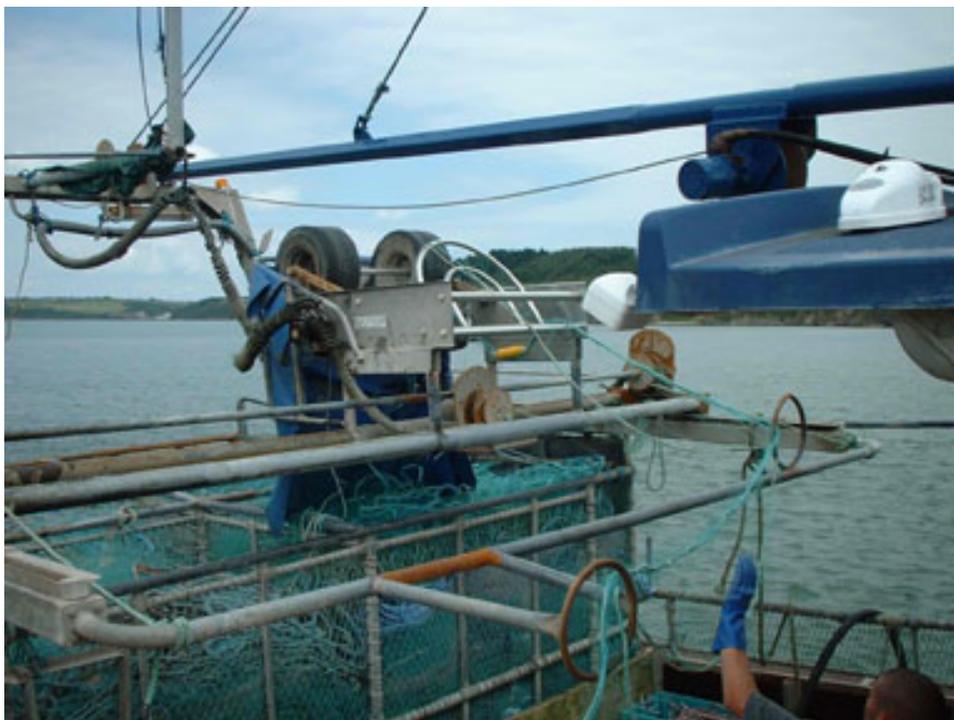
Figure 7. Net flaking machine and net pounds onboard MFV Western Dawn

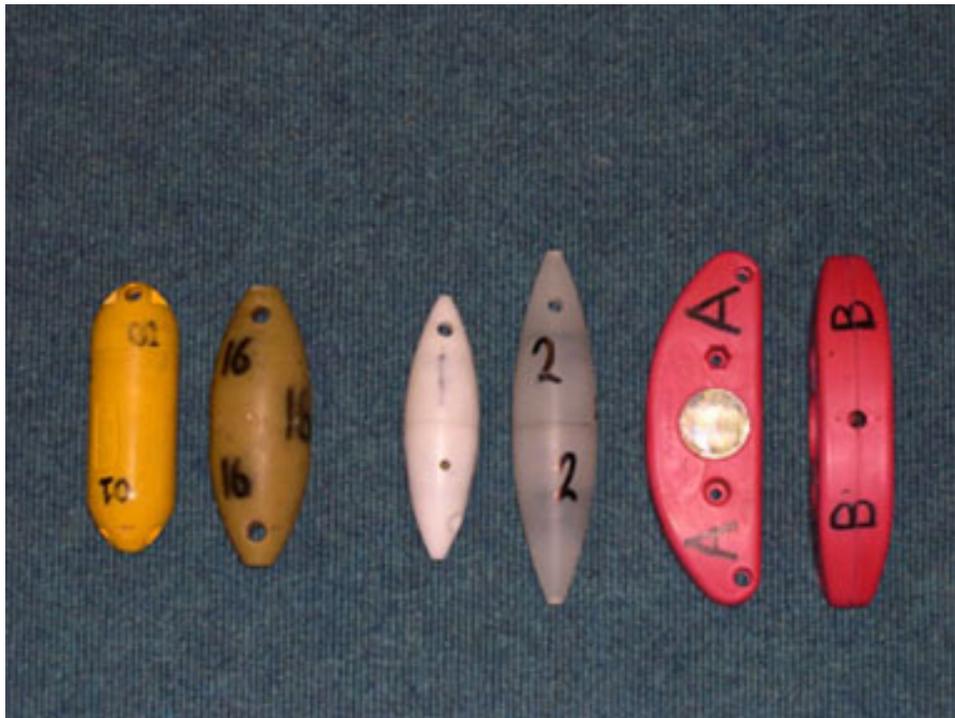
Figure 8. Airmar, Aquamark 100, Fumunda, Prototype Fumunda and Savewave (side and top view) pingers

Four types of acoustic deterrent devices/pingers were used in this study. The characteristics of these pingers are described in Table 4 and are based on the latest information acquired from the manufacturers. It should be noted that the Fumunda pingers were changed after Trial 1. In Trial 2, Fumunda supplied a new model with a modified battery holding tray and a stronger contact spring. The company also supplied 2 modified prototype pingers with increased buoyancy for use on tangle nets and these were tested in Trial 2. These prototypes were dummy models, as they did not contain any electronics (Figure 8). Apart from the changes to the Fumundas, the same pingers used in Trial 1 were used in Trial 2.

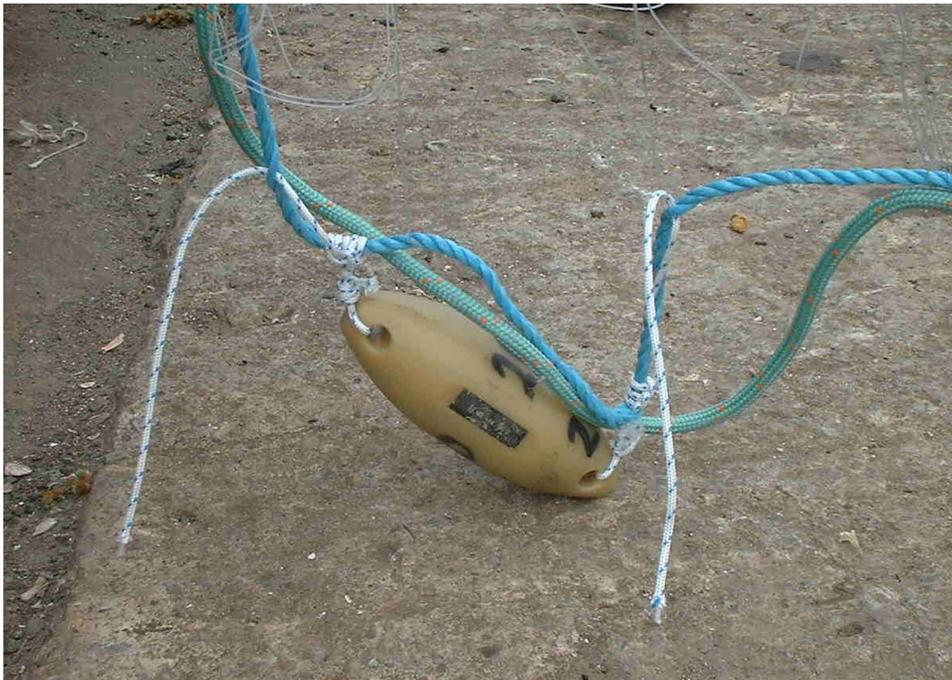
Figure 9. Attachment of Aquamark pinger to 3-strand headrope

A piece of twine, approximately 40 cm in length of twine was made fast to each of the 2-way attachment points located at either end of the pinger. The same attachment method using the 2 holes at each end was employed for all pingers (2-way and 3-way). The pinger was then knotted directly to the headline. The twine was anchored through the headrope by opening the strands of the polypropylene rope and passing a turn of twine through the lay of the rope. The knot used to attach twine to the pingers was the hangman's knot. The knot used to attach the twine to the headrope was the rolling hitch, with the addition of a turn through the lay of the polypropylene rope (Figure 9). Excluding the Savewave all of the pingers were negatively buoyant in water and were therefore attached adjacent to net floats in order to reduce the likelihood of the headrope sinking under the weight of the pinger.

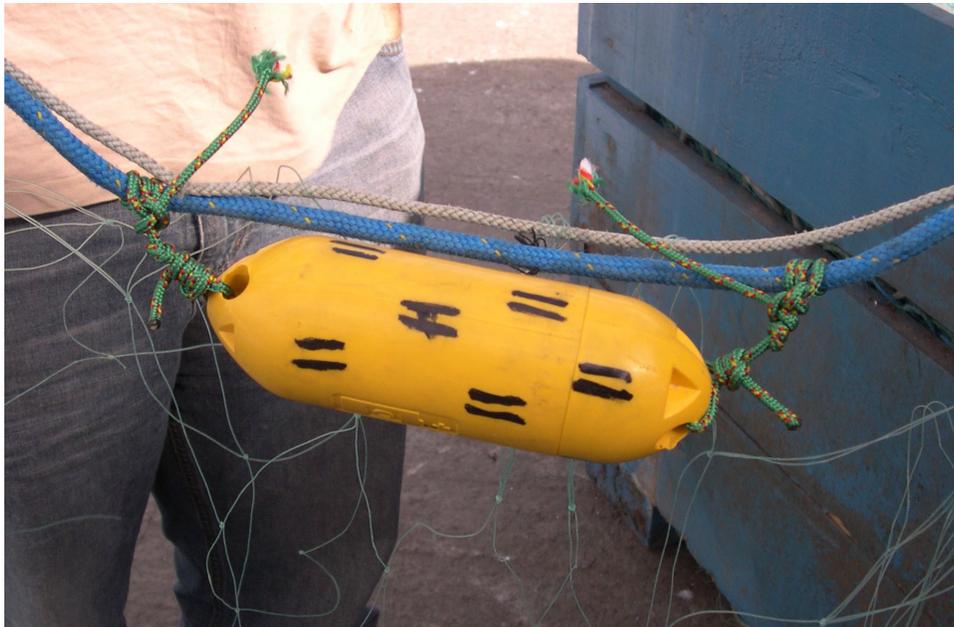
Figure 10. Attachment of Airmar pinger to solid braided headrope

Secondly, the headrope on the tangle net in this trial was solid and it was therefore not possible to tie the pingers through the lay of the rope (Figure 9). Thus unmodified pingers were attached directly to the headline in order to assess the integrity of the knots on the single strand compared to the 3-strand rope.

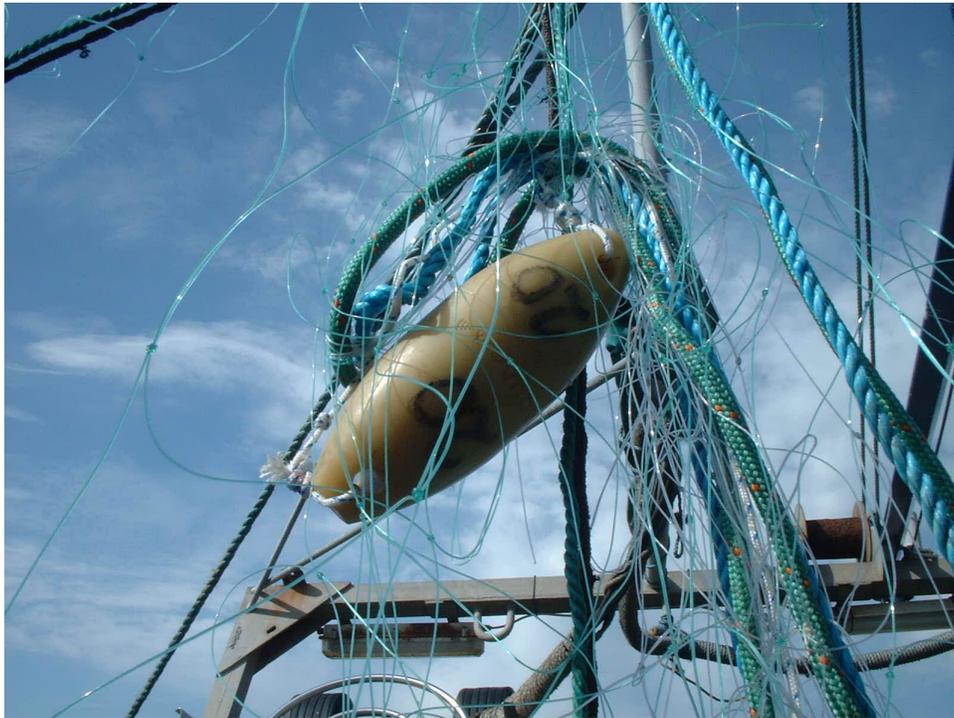
Figure 11. Pinger fouled in a tangle net

Problems arose as the gear was lifted off the deck by the flaking machine. Pingers that had fouled in meshes did not allow the headrope and footrope to be separated in the flaking machine. Similar problems as occurred in Trial 1 occurred with the flaking machine jamming and gear transported fouled into the net pounds, but on a more frequent basis.

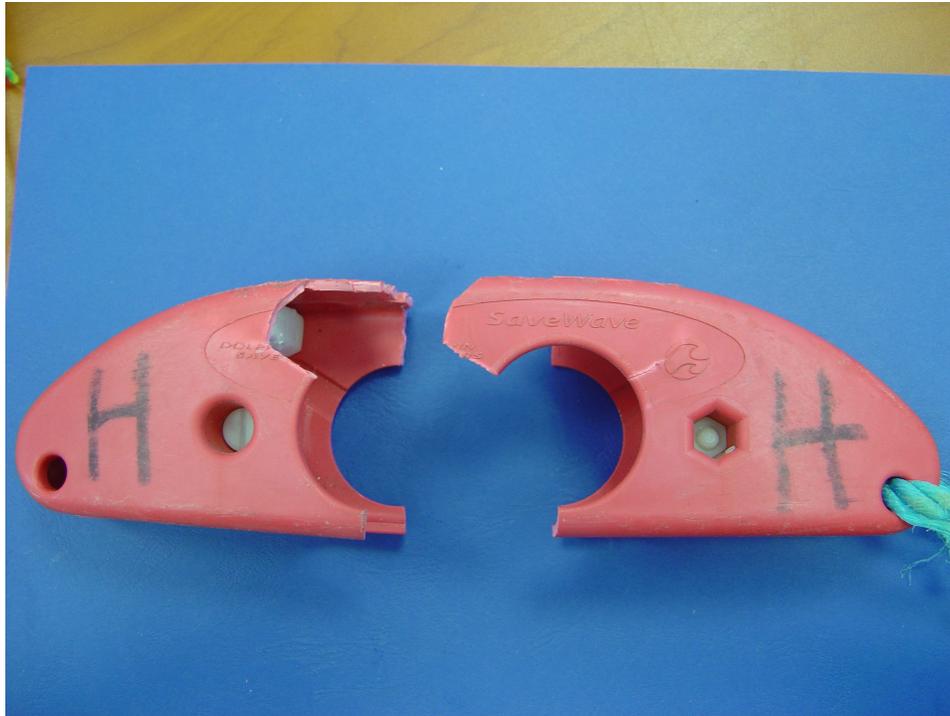
Figure 12. A Savewave snapped in two during gill net trials

At the end of the endurance trial (TDC), pingers were detached from the gear and examined ashore. Two Savewaves were lost, one without trace, while the other had snapped in half losing the electronics unit (Figure 11).

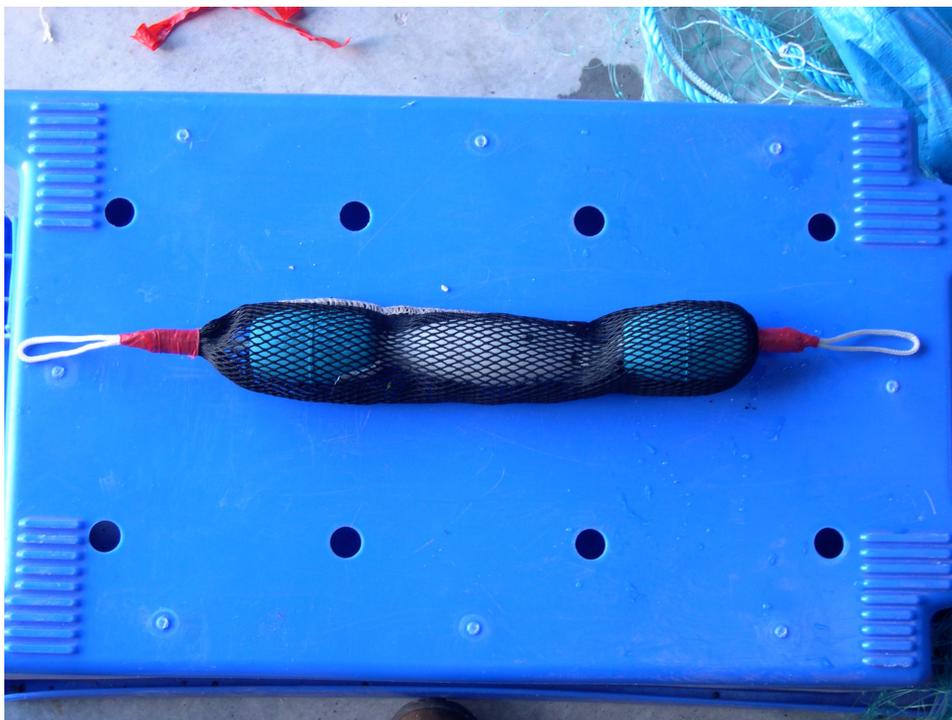
Figure 13. Modified Bait Bag

The system of pinger modification was further developed during the trial and the final version consisted of a single pinger unit between floats within bait tubing, with the end parts of the tubing tightly whipped with 3mm white nylon cord around a 4mm flattened nylon central cord holding both the pingers and the floats. Electrical taping was used to bind the nylon cord tightly with the bait tubing, creating a loop of nylon cord at each end, which simplified and speeded up the detachment and reattachment process (Figure 12).

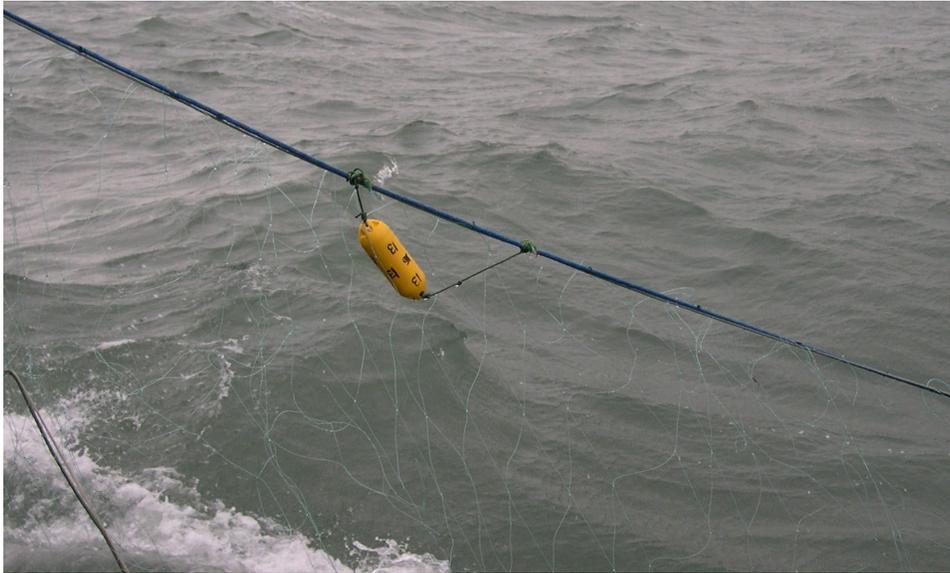
Figure 14. A pinger coming loose on a solid braided headline

Slightly different attachment knots were employed on the solid headrope in Trial 2 given that it was not possible to pass attachment cords through the lay of the rope. Consequently the knots attaching the unmodified pingers were observed to loosen over time and some eventually worked free (Figure 13). This problem was observed to occur more frequently on the solid headrope than other headropes. Heavier pingers such as the Airmar and Aquamark were more prone to knot slippage than the lighter Fumunda and the buoyant Savewave. Modified pingers attached directly to the headrope also showed signs of knot slippage.
