Bord Iascaigh Mhara
Irish Sea Fisheries Board

The assessment of fish quality before and after a device used to separate pelagic fish (mackerel) from offloading delivery water

31 August 2013

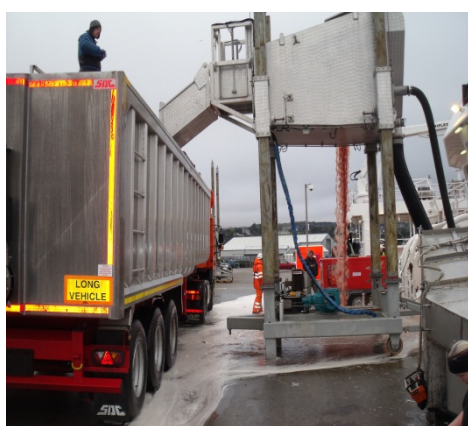
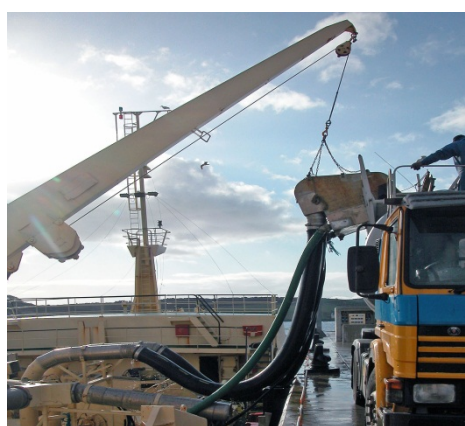
Figure 1. Devices used to separate pelagic fish from offloading delivery water: (a) Proposed device subject to this assessment, (b) Device used by pelagic vessels to recover or discharge delivery water.

At the request of the Sea Fisheries Protection Authority (SFPA), the quality of mackerel before and after a device used to separate pelagic fish from offloading delivery water (Fig. 1a), was conducted by BIM on 30th November 2012 at the new pier, Killybegs.

It should be noted that the quayside separator, which forms the subject of this assessment is similar in operation principles to that which is normally used by vessels to separate or recirculate the majority of tank water from fish at discharge (Fig. 1b).

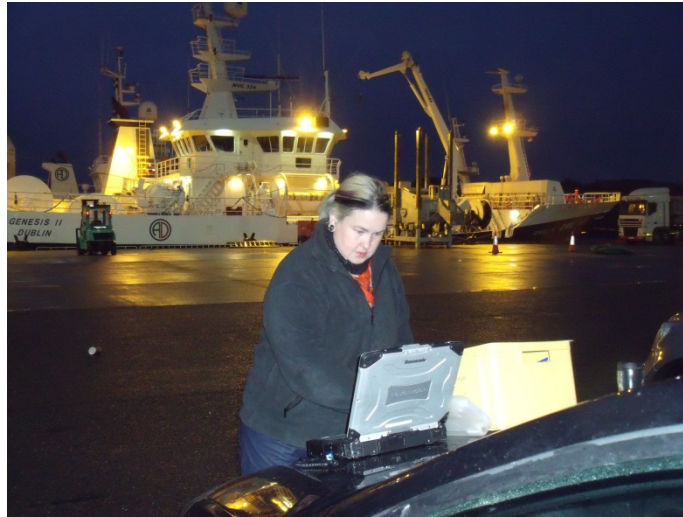
Figure 2. 30 November 2012; 07:30. *Genesis II* alongside the new pier in Killybegs. Separator in position and BIM staff launching temperature loggers in preparation for the quality assessment procedure.

BIM staff arrived at *Genesis II* alongside the new pier in Killybegs, at the time agreed with the SFPA of 07:30. The ambient air temperature was recorded as 2°C (Fig. 2).

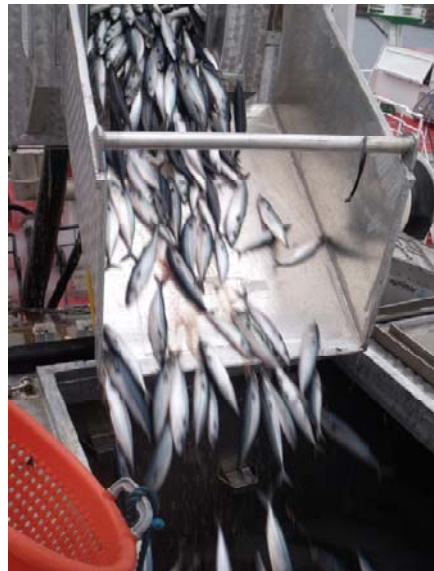
Figure 4. Preparing to take a sample of fish from the top of the tanker at the point of exit of the fish from the separator.

The post-separator sample was taken at 11:18 using a fish basket placed under the flow of fish exiting the separating device on top of the transport tanker (Fig. 4).

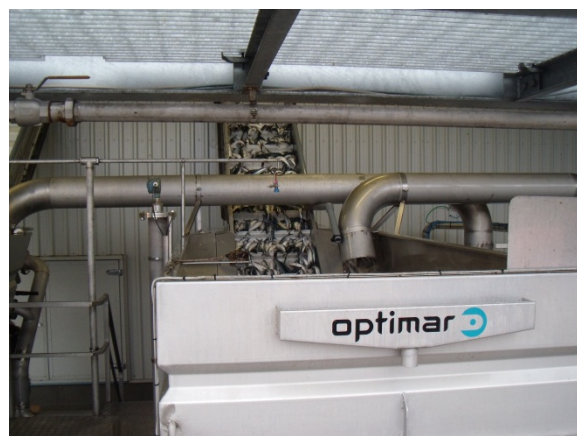
Figure 5. Fish being received by the processor following discharge from the tanker.

The final sample was taken at 11:33 from the tank to which fish was discharged from the transport tanker. Discharge began at 11:30 and finished at 11:55 (Fig. 5).

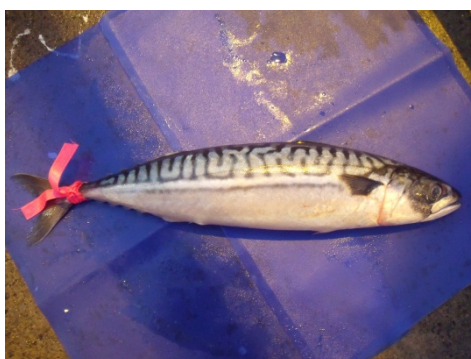
Figure 7. A mackerel tagged and with logger inserted and ready for return to the RSW tank of *Genesis II*.

A *Dwyer BDL-1* (www.dwyer-inst.com) button temperature logger (0.5°C resolution) set to record temperature at 1 minute intervals (Fig. 6), was inserted into the mouth of each fish and pushed down into the stomach. A paper label, numbered in pencil, was inserted into the mouth of each fish and an identification tag of pink polyethylene ribbon, numbered using a black marker, was tied around the caudal peduncle (i.e. the end of the body before the tail) (Fig. 7).
